**Address** Example House

**Survey Date** 21st February 2022

**Prepared by** Jack Pye BSc Hons, MRICS  
Novello Chartered Surveyors

**Date of issue** 22nd February 2022

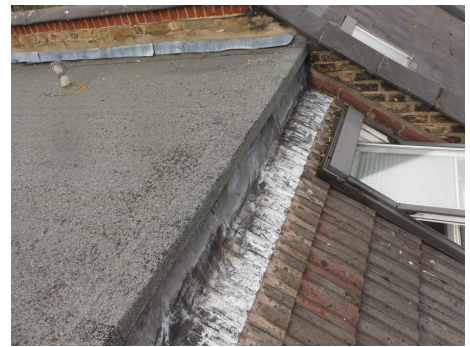
The felt roof coverings to the flat roof to the roof extension are old, badly weathered and starting to become brittle. It is likely that this roof is nearing the end of its serviceable life and will require replacement in the a medium term.

Photo 12 - Lead and felt badly weathered

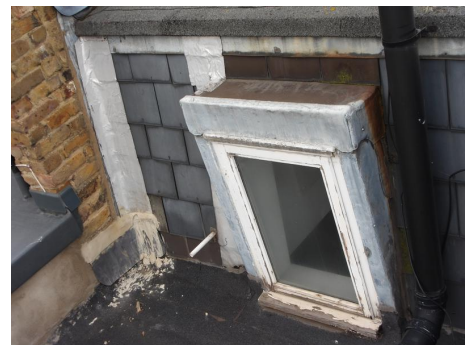
The leadwork appears slightly untidy and lifted around the dormer windows to the mansard roof. A section of this leadwork to the rear right side of the roof extension has been repaired with flashing tape and this is an inadequate short-term repair. The lead claddings around the rear dormer windows are starting to rust and corrode. Given the exposed location these parts of the property can be subjected to serve weathering and it is vital that the lead joints are in good order. Over time the leadwork can shrink and crack when subjected to differential thermal movement between the timber roof and leadwork. We would recommend that a roofing contractor is instructed in the short term to access the roof and undertake any necessary repairs or renewals to the lead work. Some sections of the lead may need to be replaced in the medium to longer term, but patch repairs may suffice for now. You may wish to obtain quotes for this before proceeding.

Photo 14 - Flashing tape repairs

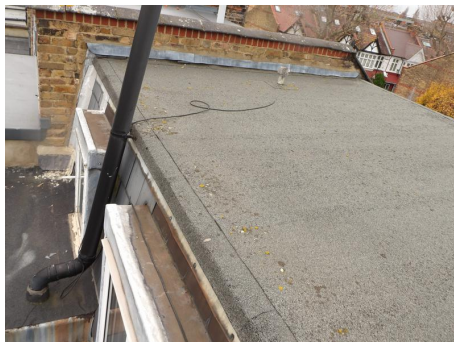
Photo 15 - Badly weathered felt

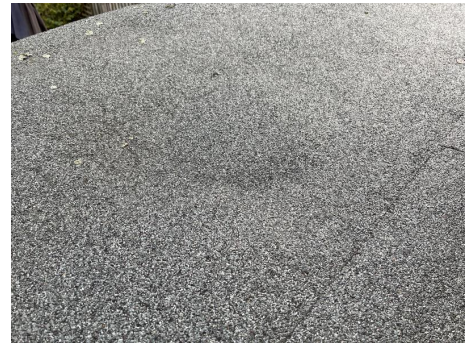
The felt coverings to the single storey rear extension roof were rather weathered and we noted a few air pockets which could hold water. Given the short lifespan of felt roofs (typically 10 to 20 years) these are likely to be nearing the end of their serviceable life and they require renewal and replacement in the medium to longer term. Until such time they should be monitored for any leaks to the areas below.

Photo 28 - Air pocket to felt

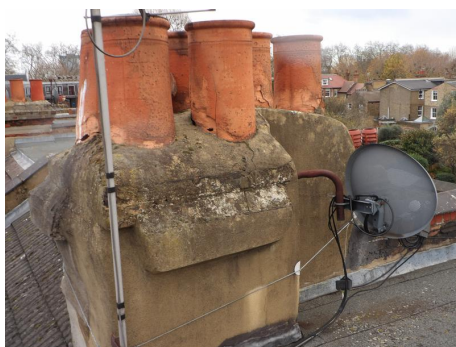
The render to the chimney stacks' is slightly cracked and weathered, and this may allow dampness to penetrate through capillary action. The cracks should be raked out and filled in the short term. In the longer term some re-rendering may be necessary.

Photo 34 - Cracked and weathered render

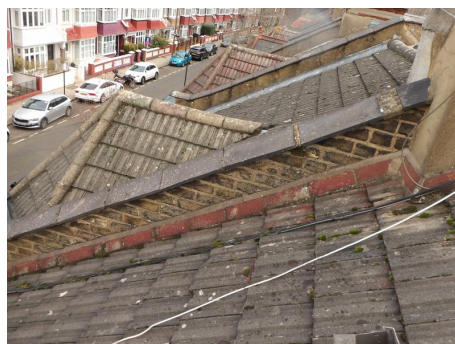
The tile fillet junction to the front parapet walls is substandard when compared to a lead flashing, as such the junction may be a weakness for damp to penetrate. We would suggest that the junction be stripped, and a lead flashing installed in the short to medium term. Until the replacement works are carried out you should monitor the internal areas for any signs of leaks.

Photo 46 - Tillet fillets inadequate

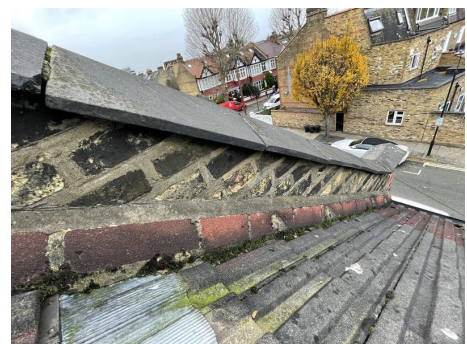
Photo 47 - Tillet fillets inadequate

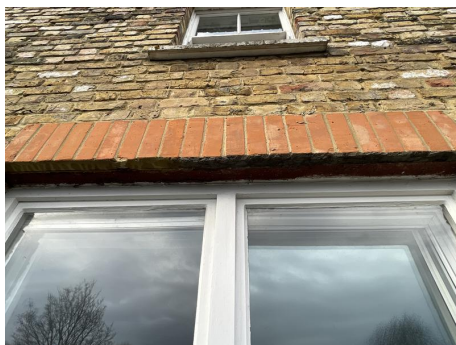
Photo 68 - Steel starting to corrode

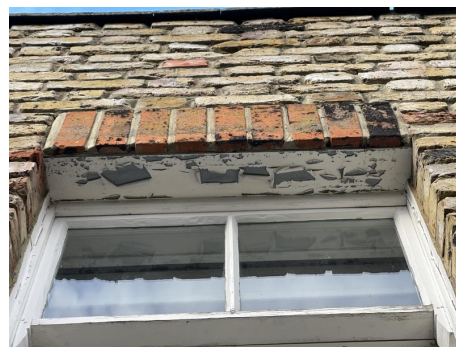
Photo 69 - Steel starting to peel and corrode

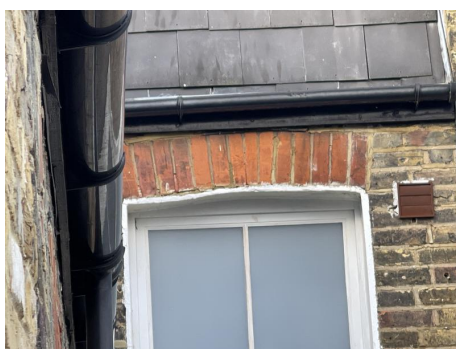
Photo 70 - Lintel dropped

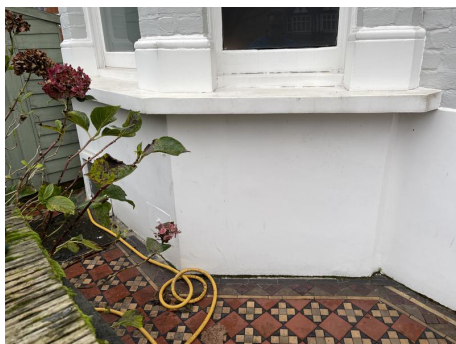
- 🔍 As there are no air vents to the sub-floor, the ventilation to the ground floor is insufficient, as such the timbers will be at risk of damp and decay. The air vents will need to be reinstated in the short term to provide adequate ventilation through the sub-floor void.

Photo 76 - No ventilation

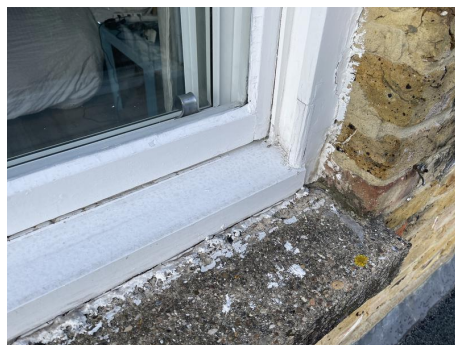
The seals around some of the windows are in poor condition. This appears to be allowing damp ingress to the rear first floor bedroom window and walls. The seal should be scraped out and renewed in the immediate the short term to prevent any further issues of damp ingress.

Photo 85 - Poor seals allowing damp ingress

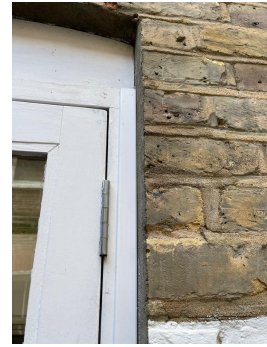
Photo 90 - Poor seals

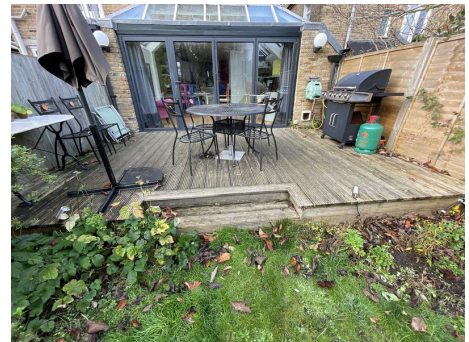
Photo 98 - Weathered timber decking

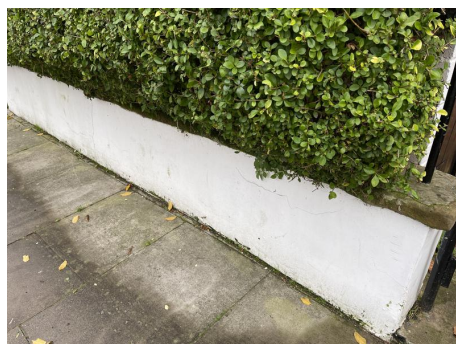
Photo 99 - Minor cracking

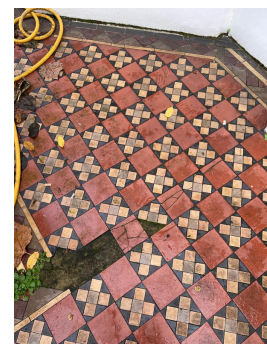
Photo 100 - Cracking tiling

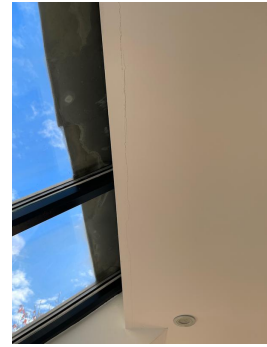
Photo 113 - Minor cracking to rear dining room ceiling

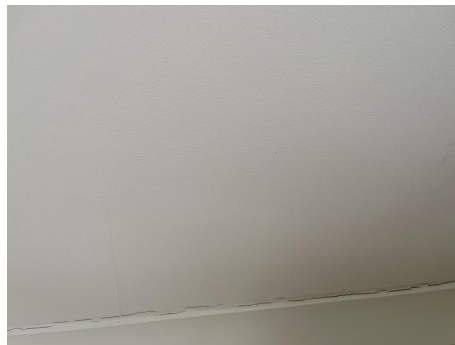
Photo 114 - Minor cracking

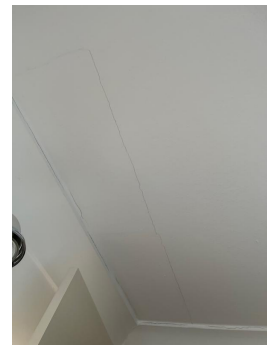
Photo 115 - Minor cracking

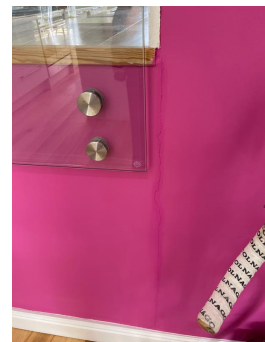
Photo 123 - Minor cracking

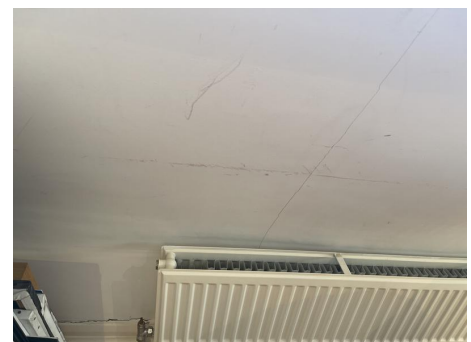
Photo 125 - Minor cracking and scuffing

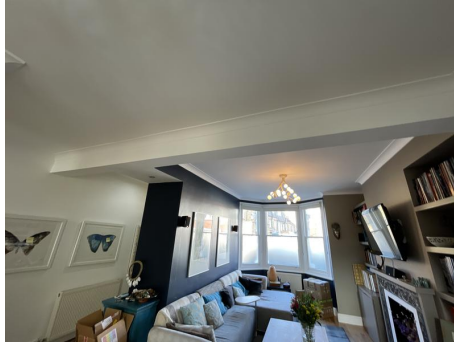
The original partitions to the ground floor have been removed to alter the layout. It is likely that these would have been a load bearing walls and as such a steel beam or similar should have been installed to support the loads above and transmit them safely around the opening. The works should have required Building Regulation approval and been signed off. Your solicitor should confirm this with the vendor. As we have not opened up the structure, we cannot confirm that the correct supports have been provided. What we can say is that there was no cracking or visible deflection to the structure to suggest that this is not the case.

Photo 130 - Cross partition to living room removed

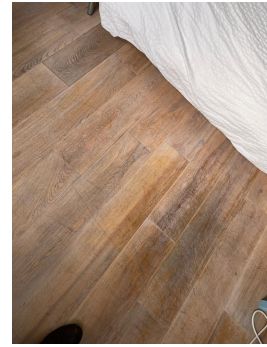
Photo 140 - Worn and scratched

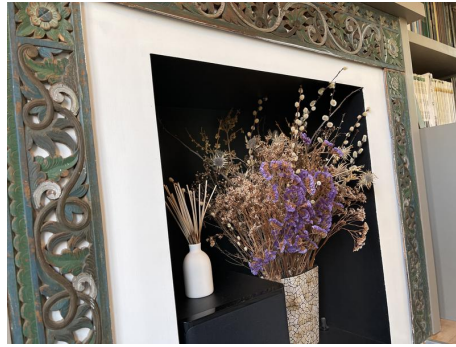
There are no air vents to the covered chimney breasts. Any unused flues or covered chimney breasts should be adequately capped and vented to prevent rain penetration and a build up of condensation within the flue.

Photo 154 - No air vent to covered fireplace

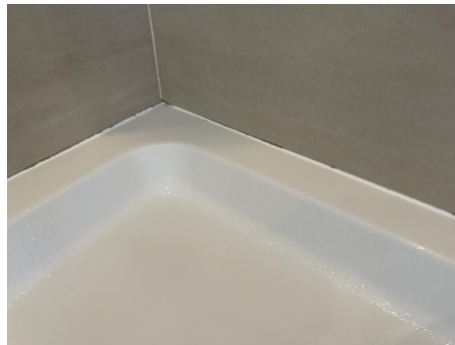
The seals to second floor bathroom and first floor bathroom baths and the ensuite shower are inadequate and should be stripped away and replaced with fresh sealant in short term.

Photo 172 - Poor seals

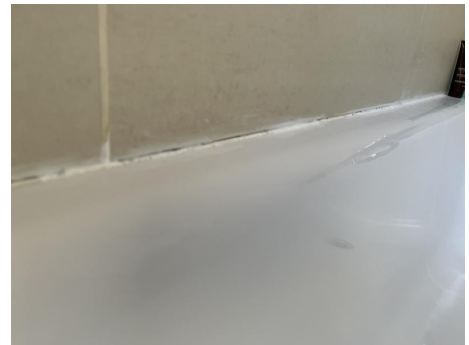
Photo 173 - Poor seals

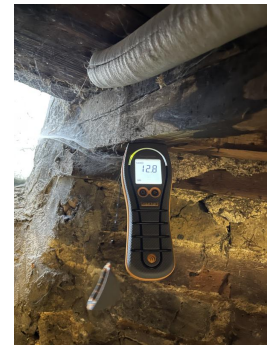
Photo 182 - Stained timber generally dry when tested

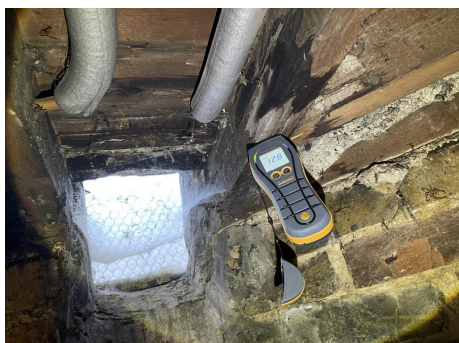
Photo 188 - Stained timber generally dry when tested

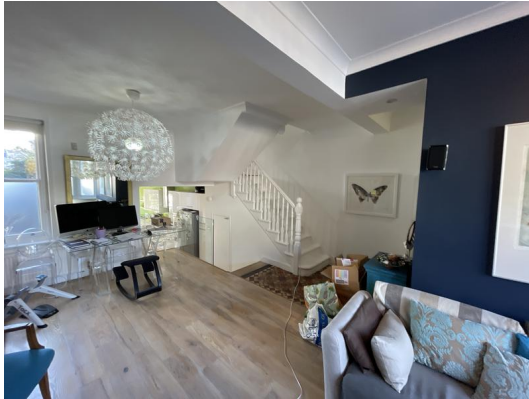
Open Plan layout with no protected fire escape route
