NOVELLO

Example Flat

Inspection date: 2021

1.0 Introduction

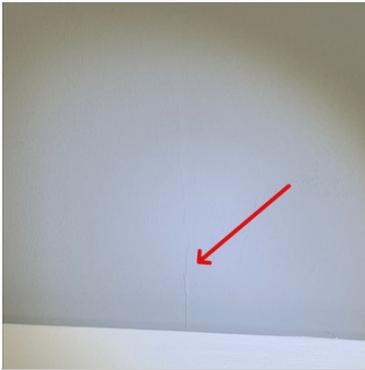
Snag 1

Shrinkage cracking above kitchen door. This should be filled in and redecorated.

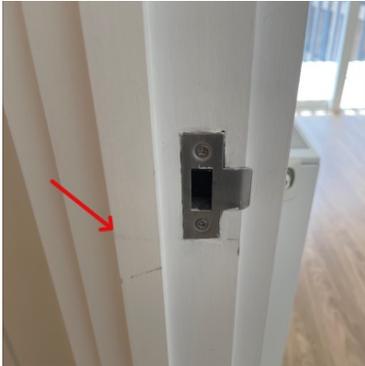
Snag 2

Kitchen door- scratched and marked paintwork requires redecoration

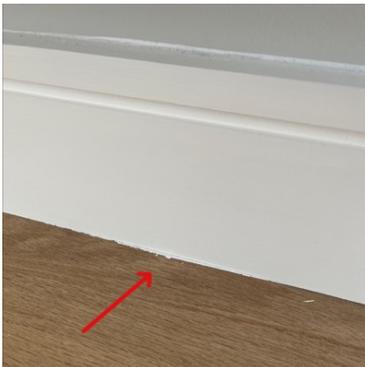
Snag 3

Kitchen flooring below radiator - untidy paintwork to skirting board junction require scraping off.

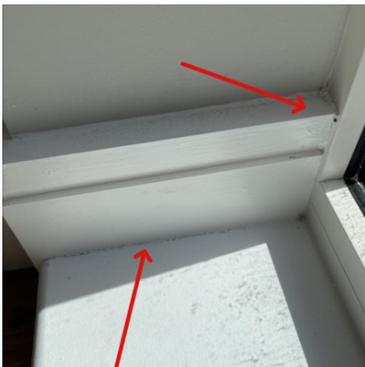
Snag 4

Kitchen window- untidy sealant and shrinkage cracking. Requires re-sealing and redecoration.

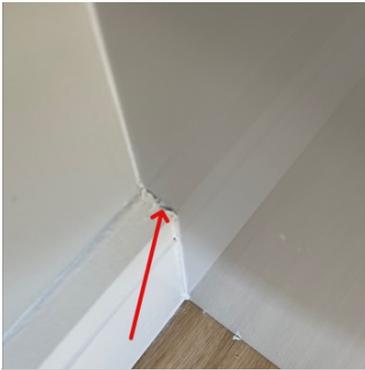
Snag 5

Skirting board where meets kitchen unit- poor sealant and cracked. Requires re-sealing.

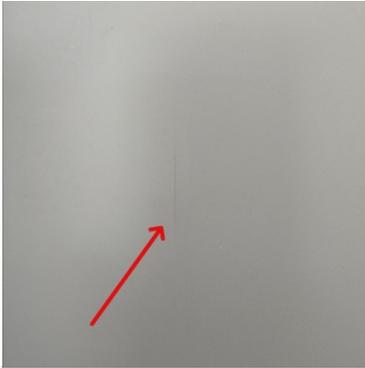
Snag 6

Rear kitchen wall next to units-cracking plasterwork. Requires filling and redecoration.

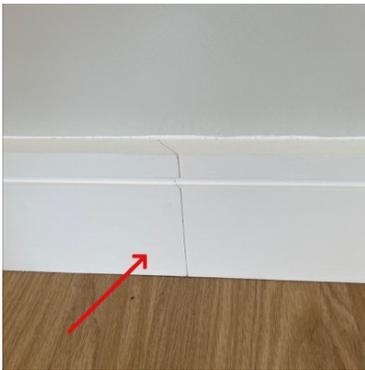
Snag 7

Rear kitchen wall skirting board- open joint. Requires filling and redecoration

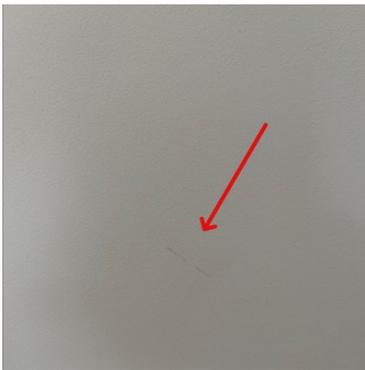
Snag 8

Rear kitchen wall-marked paint work on wall requires touching touching up

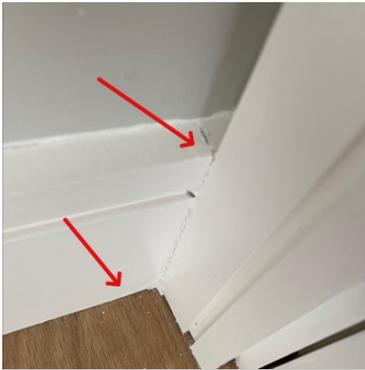
Snag 9

Skirting board to rear kitchen door next to entrance - Paint marks on the floor shrinkage cracks. Requires cleaning off filling and redecorating

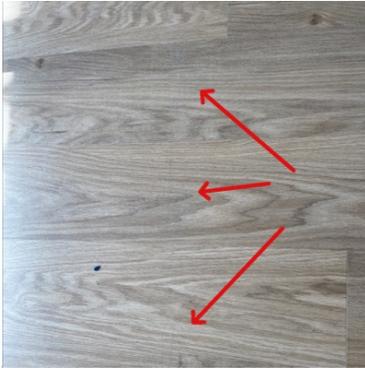
Snag 10

Kitchen floor- Glue marks next to balcony doors. Requires cleaning off.

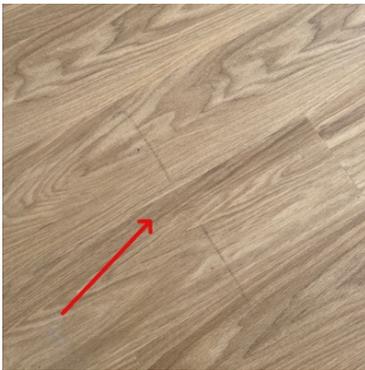
Snag 11

Kitchen floor - Numerous paint and markings require cleaning off.

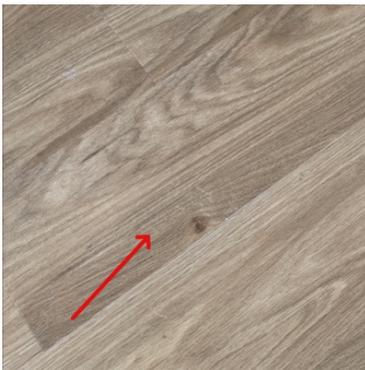
Snag 12

Kitchen floor - Numerous paint and markings require cleaning off.

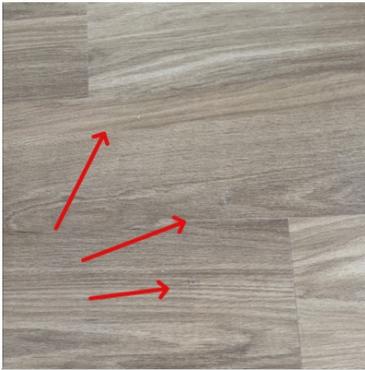
Snag 13

Kitchen floor - Numerous paint and markings require cleaning off.

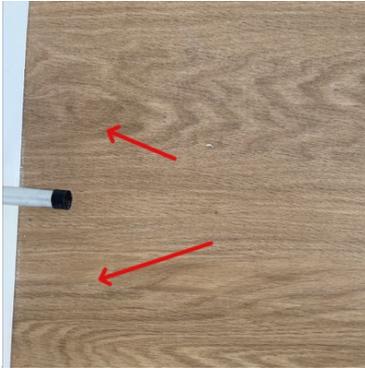
Snag 14

Kitchen floor - Numerous paint and markings require cleaning off.

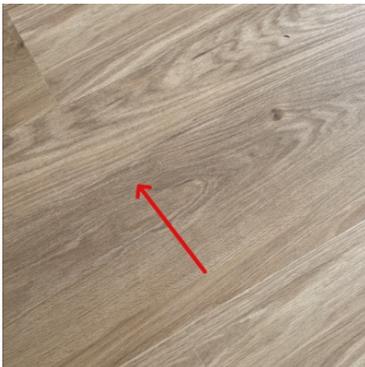
Snag 15

Kitchen floor - Numerous paint and markings require cleaning off.

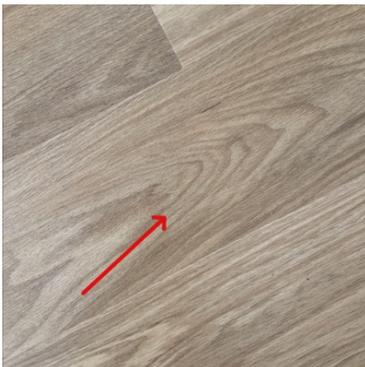
Snag 16

Kitchen floor - Numerous paint and markings require cleaning off.

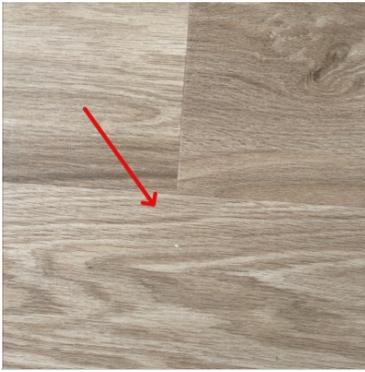
Snag 17

Kitchen floor - Numerous paint and markings require cleaning off.

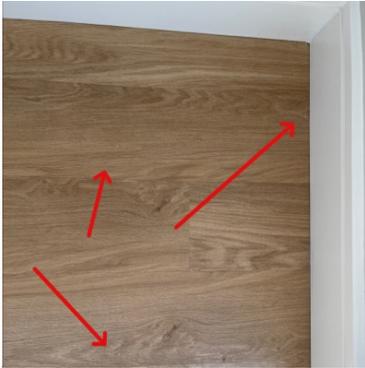
Snag 18

Kitchen floor - Numerous paint and markings require cleaning off.

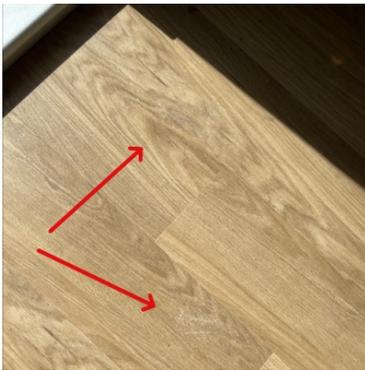
Snag 19

Kitchen floor - Numerous paint and markings require cleaning off.

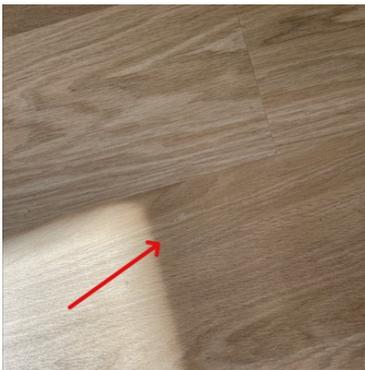
Snag 20

Kitchen floor - Numerous paint and markings require cleaning off.

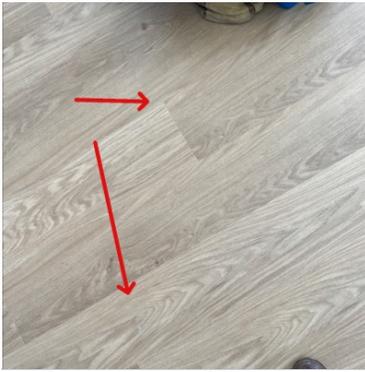
Snag 21

Kitchen floor - Numerous paint and markings require cleaning off.

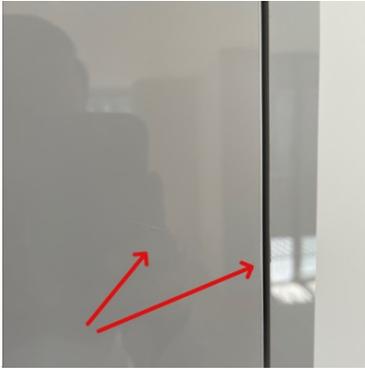
Snag 22

Kitchen unit above dishwasher-scratching

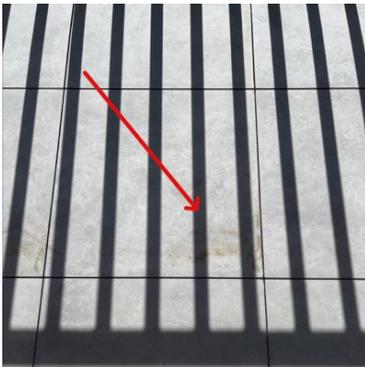
Snag 23

Balcony-staining to tiles. Requires cleaning off.

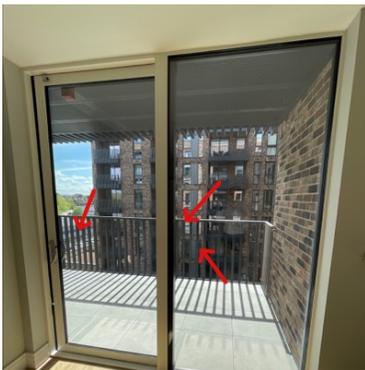
Snag 24

Balcony doors- slight scratches to glazing.

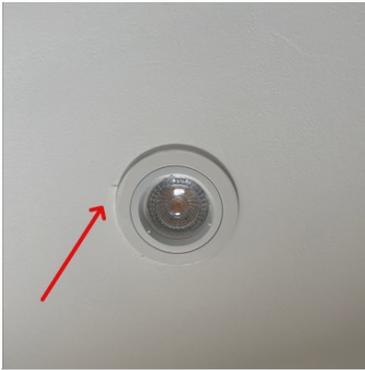
Snag 25

Lighting- various paint markings around spot lights. Requires cleaning up through the apartment.

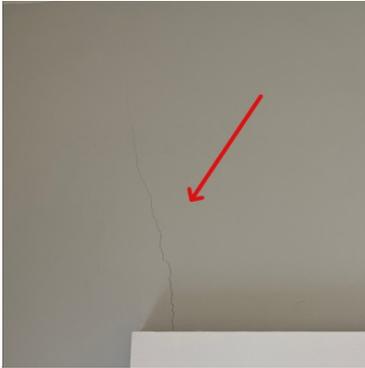
Snag 26

Hallway wall above kitchen door-cracking in plaster. Requires filling and redecoration.

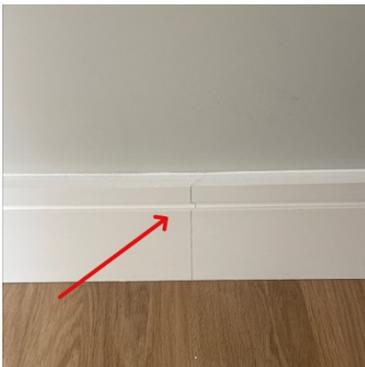
Snag 28

Right hand wall skirting board leading to kitchen. Gap in board. Requires filling.

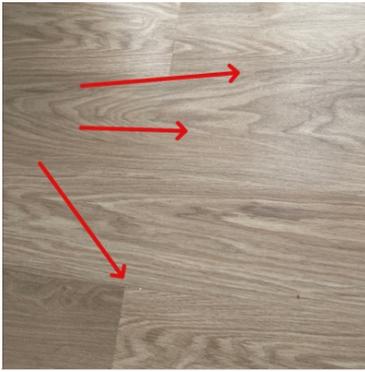
Snag 29

Hallway floor - Numerous paint and markings require cleaning off.

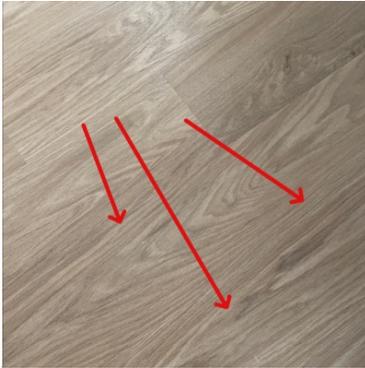
Snag 30

Hallway floor - Numerous paint and markings require cleaning off.

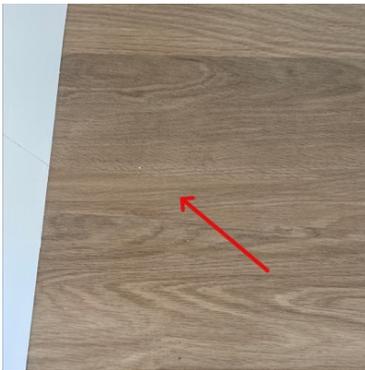
Snag 31

Hallway floor - Numerous paint and markings require cleaning off.

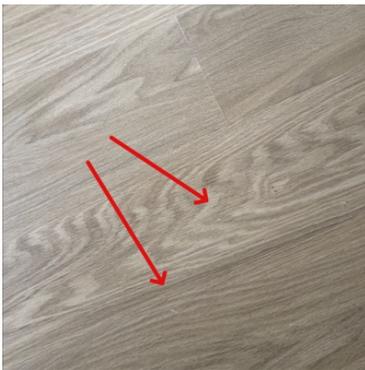
Snag 32

Hallway floor - Numerous paint and markings require cleaning off.

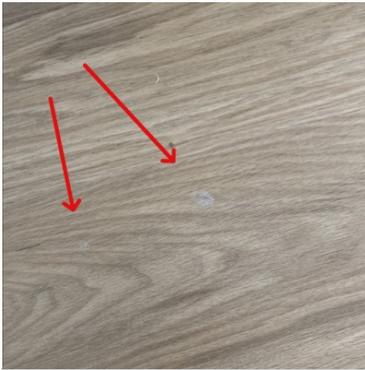
Snag 33

Hallway floor - Numerous paint and markings require cleaning off.

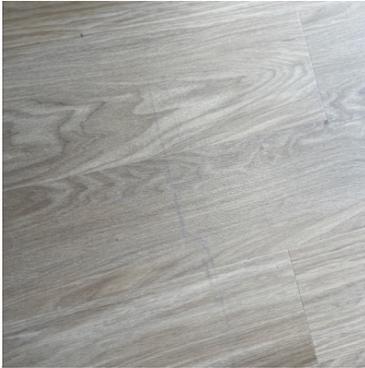
Snag 34

Hallway floor in front of second bedroom- glue markings require cleaning off.

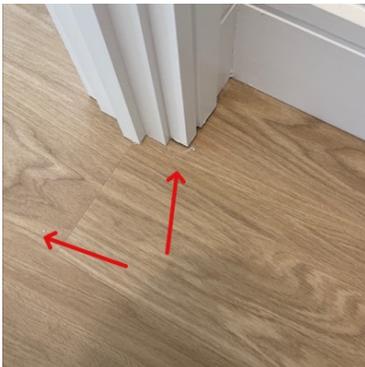
Snag 35

Hallway store cupboard- Markings on floor. Requires cleaning off.

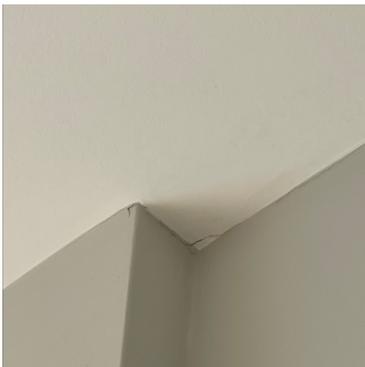
Snag 36

Master bedroom-minor cracking to ceiling above radiator. Requires filling and redecoration.

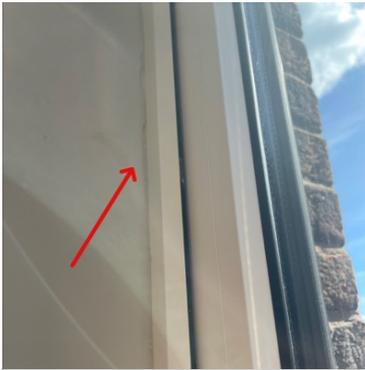
Snag 37

Master bedroom- poor decorating and sealant to window. Filling and redecoration.

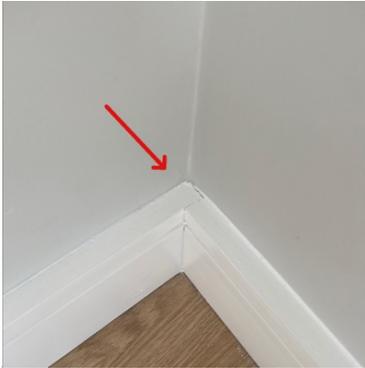
Snag 38

Master bedroom left corner to window - shrinkage crack. Refill and decorate

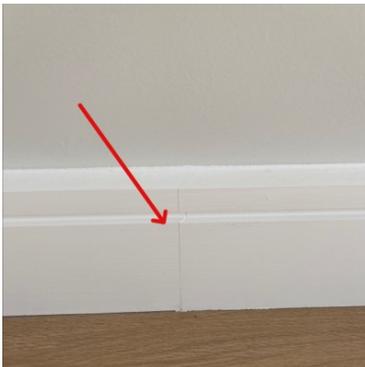
Snag 39

Master bedroom left wall skirting board- Open joint, requires refilling.

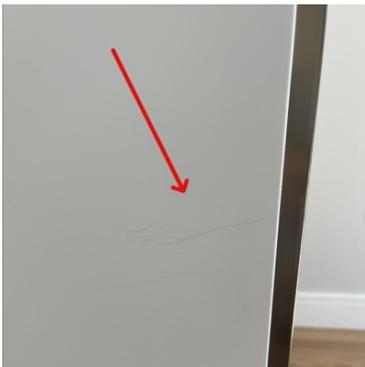
Snag 40

Master bedroom - marking to wardrobe.

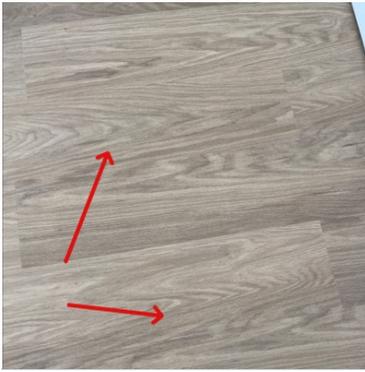
Snag 42

Master bedroom floor - Numerous paint and markings require cleaning off.

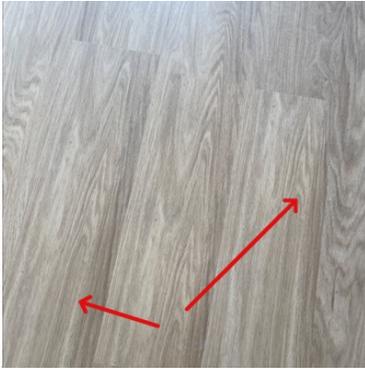
Snag 43

Master bedroom floor - Numerous paint and markings require cleaning off.

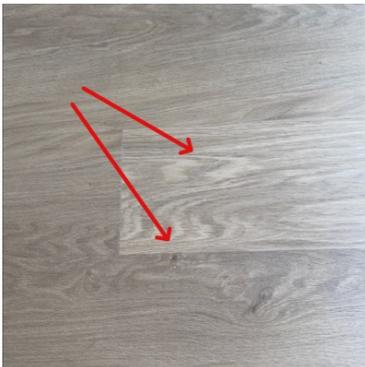
Snag 44

Master bedroom floor - Numerous paint and markings require cleaning off.

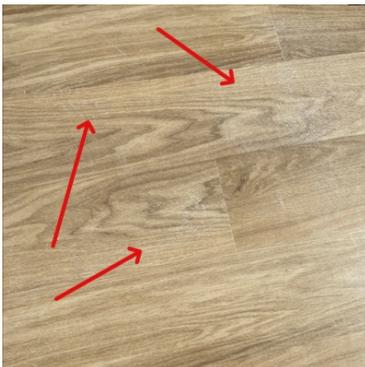
Snag 45

Master bedroom floor - Numerous paint and markings require cleaning off.

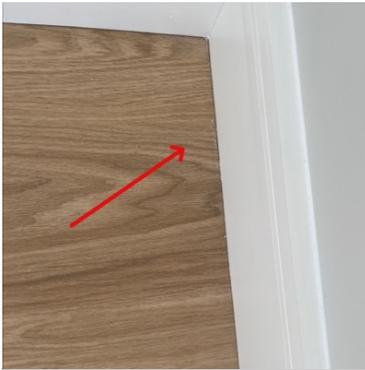
Snag 46

Master bedroom floor - Numerous paint and markings require cleaning off.

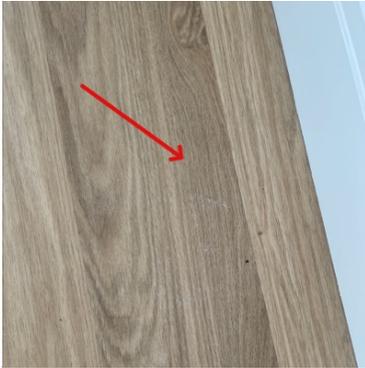
Snag 47

Master bedroom floor - Numerous paint and markings require cleaning off.

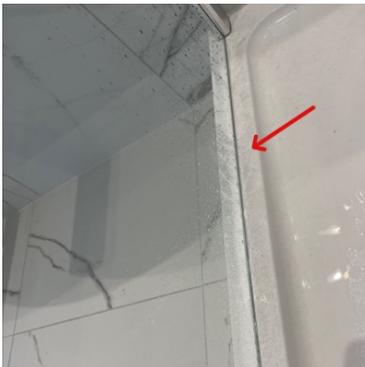
Snag 48

En-suite shower tray- No sealant internally to shower screen. Requires dealing with clear silicone.

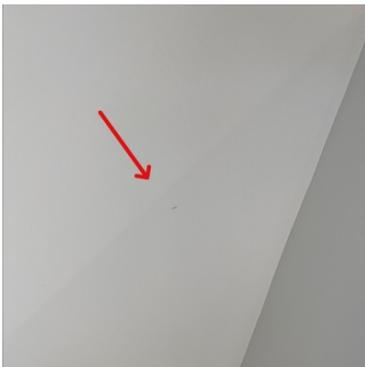
Snag 49

Second bedroom- mark in ceiling above radiator. Requires touching up.

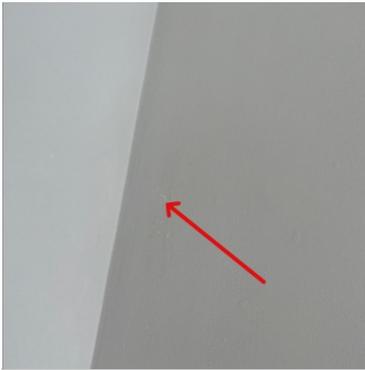
Snag 50

Second bedroom- paint blemish to left corner. Requires touching up

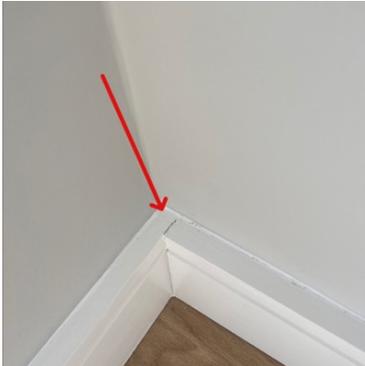
Snag 51

Second bedroom - skirting board next to radiator open joint. Requires filling and redecoration.

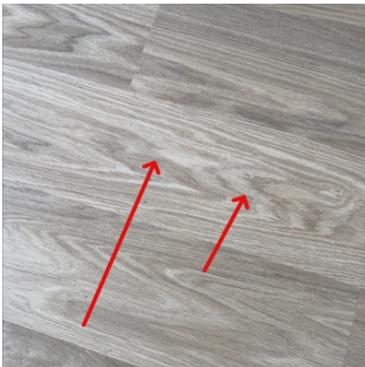
Snag 52

Second bedroom floor - Numerous paint and markings require cleaning off.

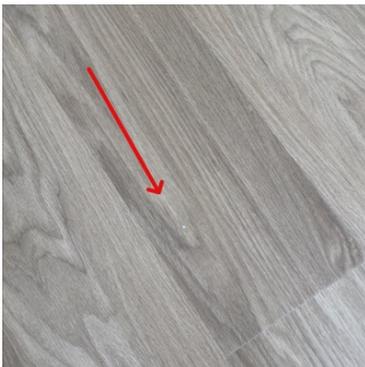
Snag 53

Second bedroom floor - Numerous paint and markings require cleaning off.

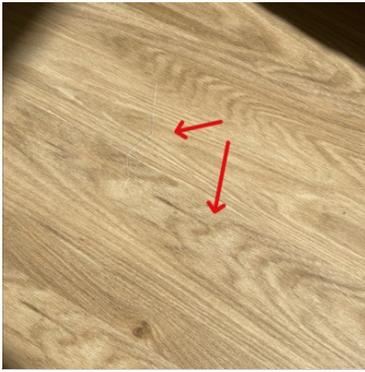
Snag 54

Second bedroom-deep scratches to flooring. Requires sections replacing.

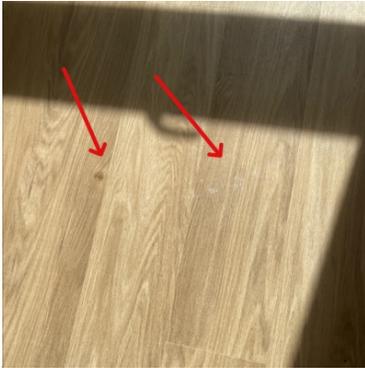
Snag 55

Second bedroom floor - Numerous paint and markings require cleaning off.

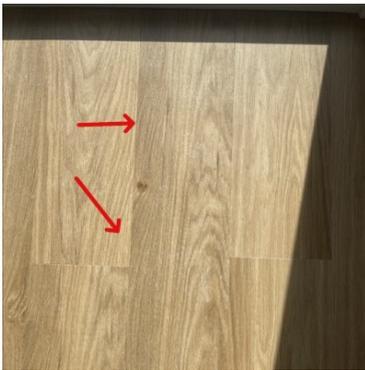
Snag 56

Second bedroom floor - Numerous paint and markings require cleaning off.

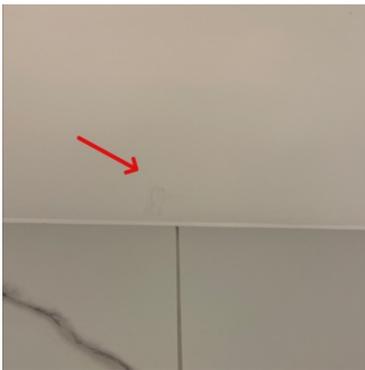
Snag 57

Bathroom-marking above sink to ceiling paint. Requires touching up.

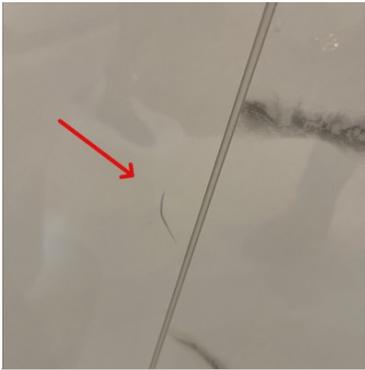
Snag 58

Bathroom- Mark on tiling next to toilet. Requires cleaning off.

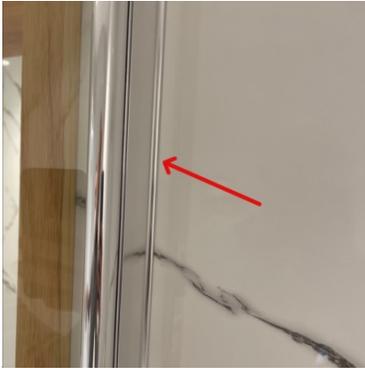
Snag 59

Bathroom- No internal sealant to shower screen. Requires sealing with clear silicon.
