HomeLevel

Example HomeLevel House

Novello Chartered Surveyors
May 2020

Prepared for Mr John Smith

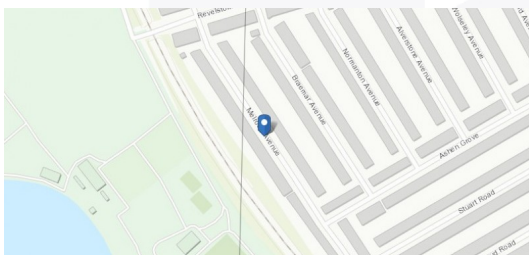
Radon Map

The “UK Radon” map shows that the property is located in a low risk area for radon.
