Address Example House

Prepared for Example Clients

Survey Date 24th October 2023

Prepared by James Brook BA(Hons), MSc, FRICS

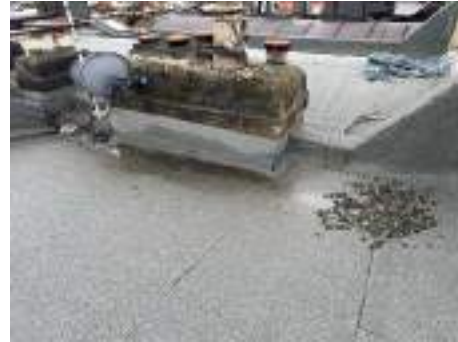
Photo 5 - Moss buildup and standing water

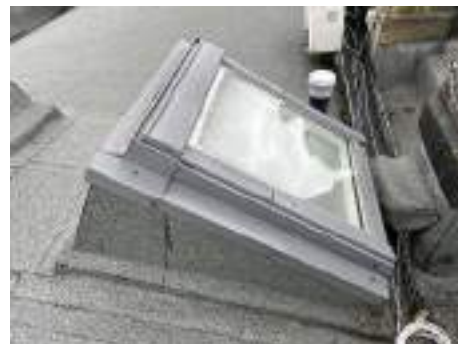
The skylight which serves the rear ensuite bathroom on the right hand side has been sealed with silicon sealant. There is also evidence of water staining beneath both of the skylights here. This indicates that past leaks have occurred. Without opening the unit we cannot confirm the cause, however, it could be that the seals around the frame are defective. However, it could also require more cost of the replacement of the whole unit. We would recommend that a contractor is instructed to open up the unit and inspect and undertake the necessary repairs or replacement. Temporary repairs may be possible, but we suspect the units will need replacing in the short term.

Photo 7 - Skylight potentially leaking requiring repair/ replacement

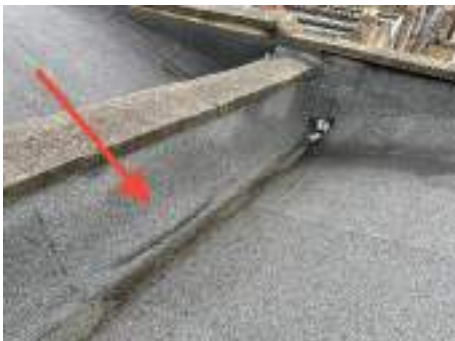
There are a few areas of weathered and untidy felt, with some small air pockets present, which could allow moisture to be trapped beneath overtime.

Photo 8 - Air pockets and untidy felt

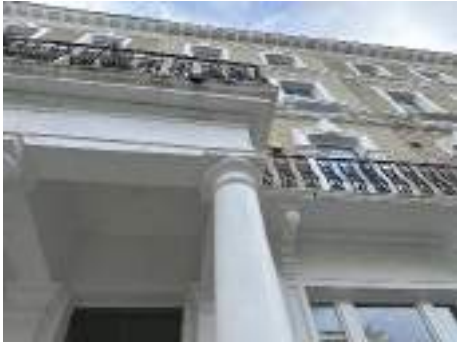
There is significant staining and blistering of the masonry and paintwork beneath the portico and balcony structures. We suspect that this is a result of the coverings being defective, as the asphalt here is rather weathered, and slightly cracked in areas. We would recommend the areas are re-covered with a deck waterproofing system and new flashing installed, with a lead drip along the edge of the balcony and portico in the short term. The area is beneath will need to be redecorated, however you may find the render and paint is now contaminated with salts which might mean the staining and blistering re-occurs- if this is the case the render will need to be hacked back and re-rendered using a breathable lime render and breathable paint.

Photo 11 - Water staining and blistering beneath the balcony and portico

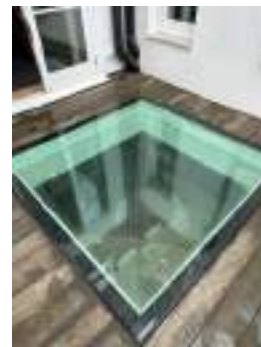
There is significant staining to the ceiling below the kitchen rooflight and this indicates the area is leaking. This could be due to the flashings or the seals, but without stripping back the area it is not possible to confirm the cause. We would recommend that the decking is stripped and the unit inspected - it is likely the glazed unit will need to be replaced and a new flashing installed, some works to the roof coverings may also be required when exposed. This should be done in the immediate term. Condition Rating 3.

Photo 13 - Rooflight leaking

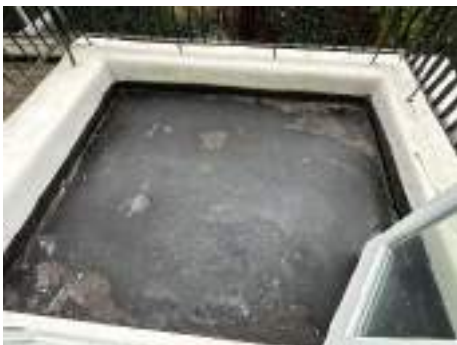
There is evidence of dampness and leaks to the cloakroom below the two storey extension roof. Externally, the asphalt coverings to the roof are rather weathered and cracked in areas. The roof should be re-covered and the flashings replaced in the short term to prevent further issues of water ingress. Condition Rating 3.

Photo 14 - Cracking to asphalt roof

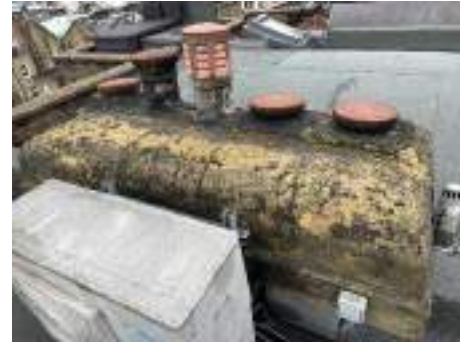
The render to the chimney stacks is cracked, blown and weathered, and this may allow dampness to penetrate through capillary action, resulting in possible internal dampness and further damage to the masonry. The cracked and damaged render should be raked out and filled in the medium term. In the medium to longer term some complete re-rendering may be necessary.

Photo 20 - Cracked render and no ventilation to the covered chimney flues

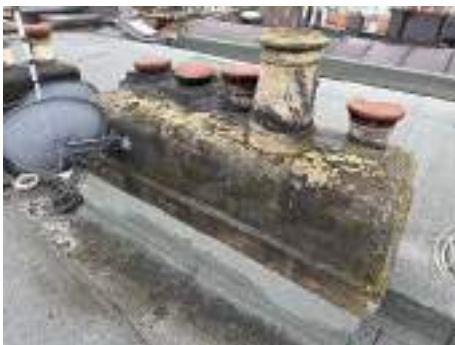
Photo 21 - Cracked render and no ventilation to the covered chimney flues

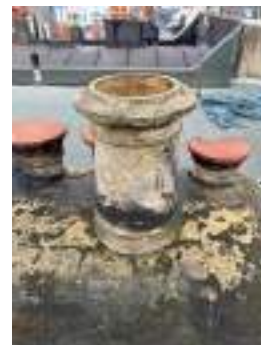
Photo 22 - Open pots

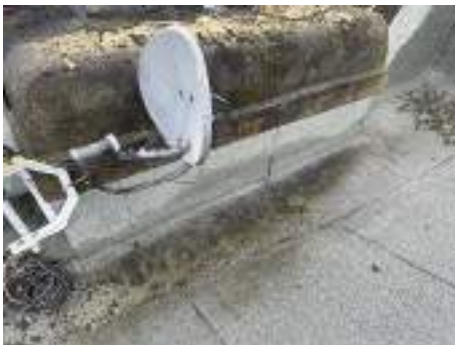
The felt flashing junction detail around the stacks is substandard when compared to a lead flashing. As such the junction may be a weakness for damp to penetrate. The junction should be stripped, and a lead flashing installed in the medium term. Until the replacement works are carried out you should monitor the internal areas for any signs of leaks.

Photo 24 - Felt flashings, not as good as lead flashings

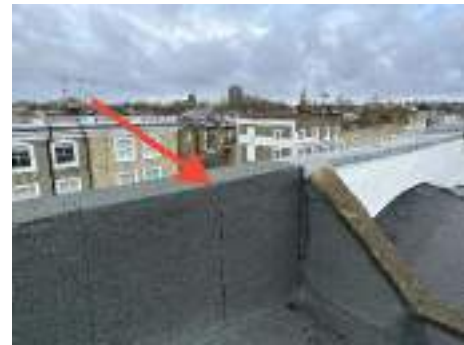
Photo 30 - No lead capping

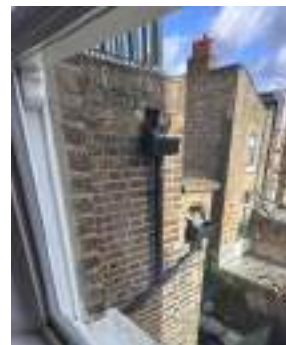
The roof above the utility room does not have any coping stones to project water away from the walls and prevent it soaking the brickwork below. This may be contributing to the issues of dampness and conditions to the utility room below. We would recommend that either copings or a lead capping is installed here in the short term. The other lower roof parapets do not have copings which sufficient project and these should be monitored for issues, again you may wish to replace the copings or install a lead capping.

Photo 32 - No coping stones

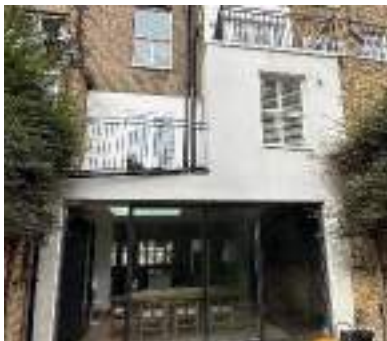
Photo 33 - Insufficient copings

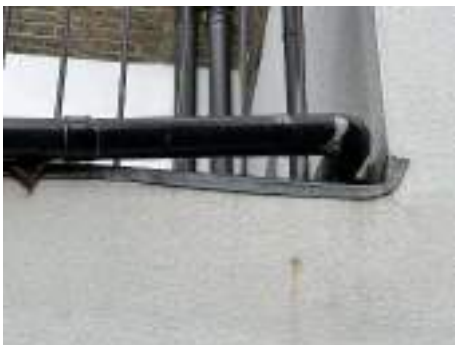
There is some white staining to some of the joints to the gutters and downpipes, suggesting that these may leak. We also note that the joints to the rear appear to have been repaired with some form of sealant. We suggest you observe the rainwater goods in action when it rains next. Any areas which are seen to leak should be repaired in the short term.

Photo 41 - Stained joints, repaired

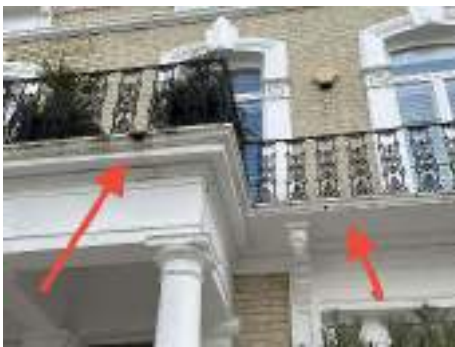
There appears to be in adequate drip grooves to most of the window sills and other areas of masonry such as the front portico and balcony. The drip grooves prevent water running over the window sill to run back along the underside of the sill which would otherwise soak the walls below. Over years the drip grooves can become blocked with layers of paint and moss allowing water to run back and soak the below walls. This has resulted in water staining in areas. We would recommend that drip grooves are cut into to the underside of the window sills and masonry to prevent water running down.

Photo 49 - Water staining as no drip grooves or cappings

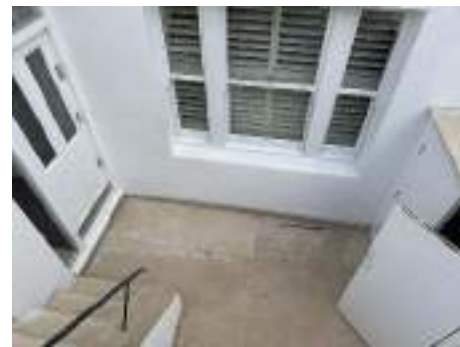
The exterior cement render continues down to ground level without interruption. As such if it becomes cracked and porous it would bridge the damp-proof course and could result in internal damp penetration. The cement

Photo 50 - Render continues to the ground

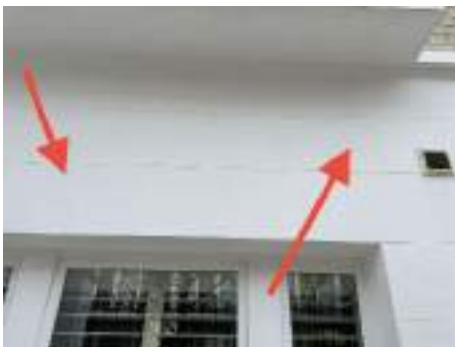
There is some minor cracking to the rendered finishes to the front lower ground area. This will require filling in and redecoration. They may re-occur overtime due to normal movement.

Photo 51 - Minor cracking to render

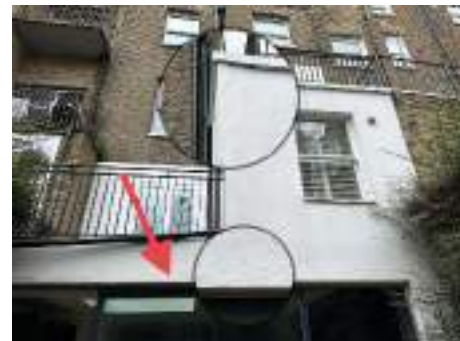
The render to the rear ground and lower ground walls is weathered, stained and blistering in areas. The sections of the render above the rear lower ground sliding doors appear to be raised, cracked and slightly hollow. These cracks could lead to issues of penetrating dampness over time, and we would recommend that any cracks are scraped out, filled and the walls redecorated to maintain their condition.

Photo 54 - Areas of cracking and blistering to the rear render

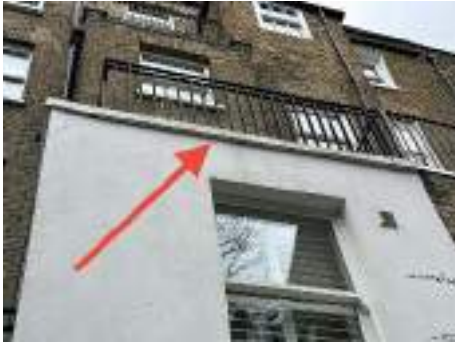
The copings to the rear first floor balcony area do not protrude sufficiently, and there are no sufficient drip grooves. I would recommend that a lead capping is installed to the copings here to prevent water running down the face of the render beneath.

Photo 55 - Copings do not project sufficiently

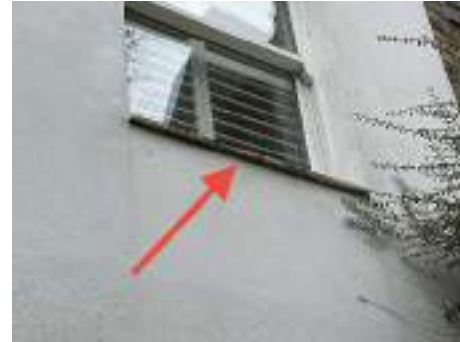
Photo 56 - Windowsill does not project sufficiently

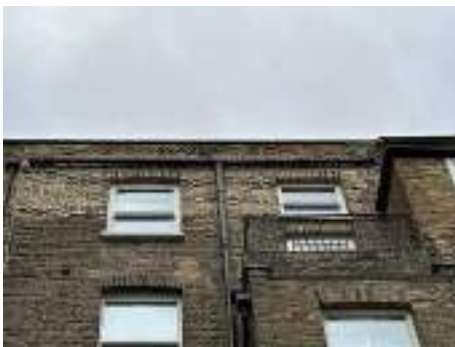
It would appear that the upper section of the rear walls have been rebuilt at some point in the past. We cannot confirm the reason for this, however amongst the possible reasons are bomb damage during the war or past defects. All we can say is that the area appears to be generally satisfactory now.

Photo 57 - Upper section of the walls rebuilt

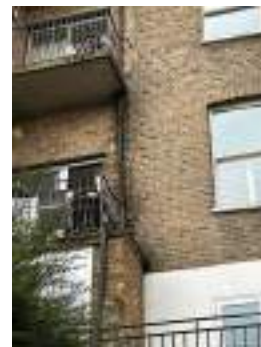
The neighbouring building to the rear has water staining to the walls, below the balconies, which appears to be due to a defective rainwater downpipe. This has resulted in water staining to the walls at the junction with your property and this could result in damp ingress. We would recommend that the neighbours are contacted to resolve this issue.

Photo 58 - Water staining to walls caused by neighbours downpipe

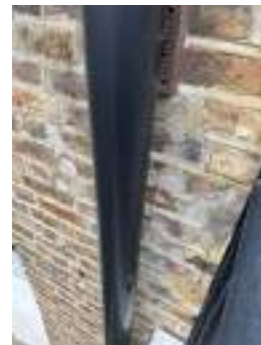
There is an untidy area of re-pointing to the rear walls next to the top balcony. The mortar to the corner junction where the main walls meets the rear additions is also cracked in areas with some plant growth. This will require raking out and adequately re-pointing in the medium to long-term.

Photo 62 - Untidy pointing

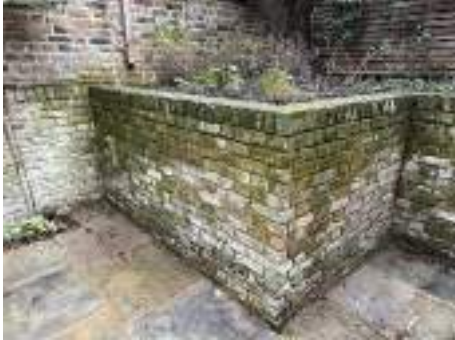
Photo 85 - Water staining

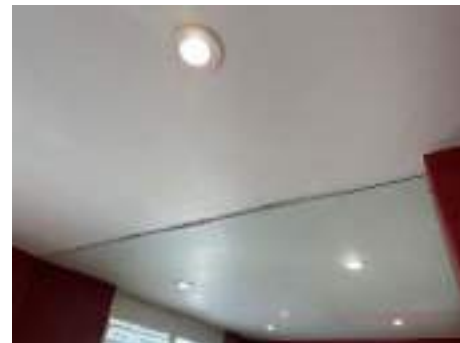
Photo 101 - Dampness to ceiling

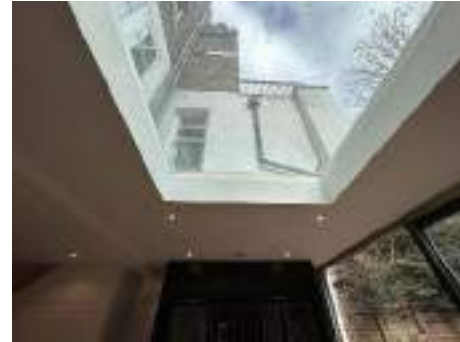
Photo 103 - dampness around rooflight

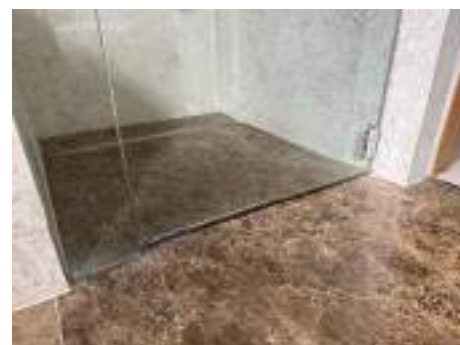
Photo 134 - Defective shower door seal

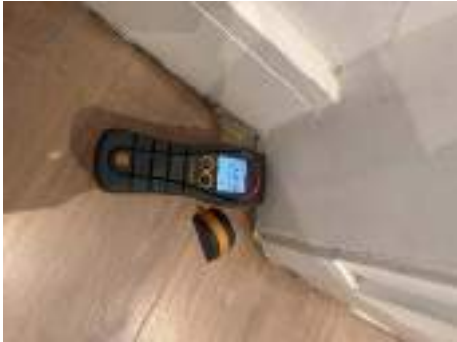
Significant dampness and evidence of staining was noted to the lower ground walls, most notably to the front living room area but this may also be present behind the kitchen fittings. This is likely due to the failure of the previous cement tanking system. You have instructed a Damp Specialist who has reported back with a quote for remedial works to re-tank the area with a cement slurry system. There are two main types of waterproofing for basements and lower grounds: application of a cement slurry or the use of cavity membranes combined with drainage channels and a sump pump. A cavity membrane system is far superior to cement slurry and typically lasts a lot longer. Such cement systems can fail after a number of years, and you may find that some damp start to present itself, requiring damp-proofing works once again. Condition Rating 3

Photo 135 - Dampness found- lower ground

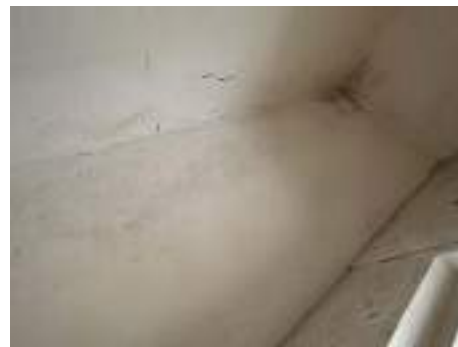
Significant dampness and staining was noted to the utility room- we suspect that this is a condensation issue as noted below. However, the roof above the utility room does not have any coping stones to project water away from the walls and prevent it soaking the brickwork below. This may be contributing to the issues of dampness and conditions to the utility room below. Condition Rating 3

Photo 140 - Dampness to utility room ceiling void

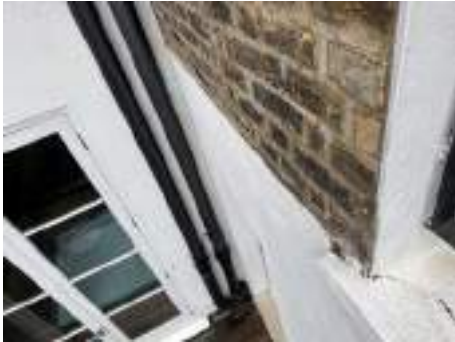
Photo 143 - Dampness possibly entering via ledge of render
