NOVELLO

CHARTERED SURVEYORS

Survey Date 2nd November 2024

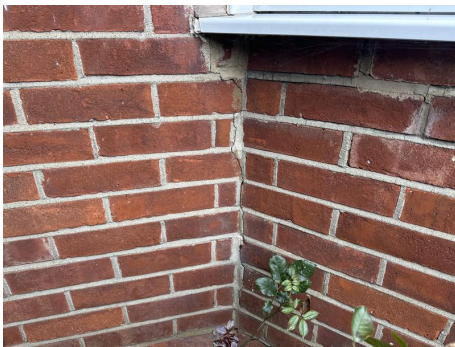
There is some cracking to the bay window especially at the junction with the main wall. Although this is not uncommon in bay windows and in a property of this age, we did note that the external wall following repointing has cracked and reopened slightly, and cracking can be seen to the internal wall which has been re-plastered. We are unable to confirm from our single inspection whether or not this movement is ongoing and serious. Typically, the foundations of the bay window will be to a different depth than to the main walls of the property. We would advise a structural engineer inspect the front bay prior to exchange to confirm if the movement is progressive.

Photo 3 - Cracking to front bay.

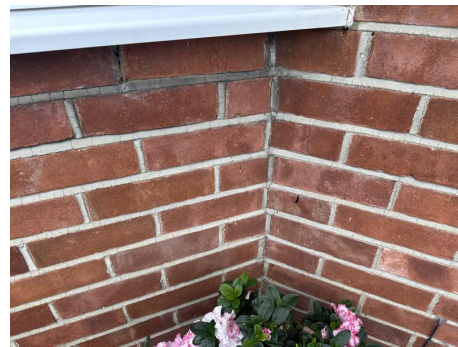
Photo 4 - Cracking to front bay.

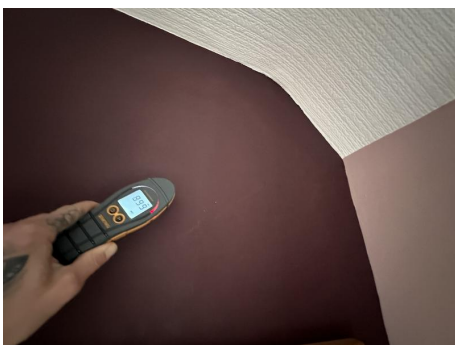
As previously mentioned, high levels of dampness were recorded to the wall in bedroom three, we suspect this is due to a leak within the water tank system.

Photo 5 - Damp to side wall, bedroom three below water tank.

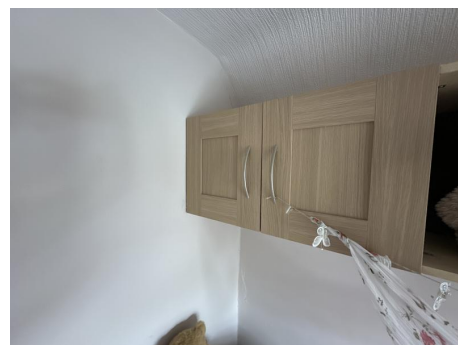
Past movement cracking can be seen to the side wall in bedroom two. Although we do not believe this to be serious, the structural engineer should also inspect the cracking, and we believe this should require some re-plastering works and monitoring moving forward.

Photo 6 - Cracking to corner, bedroom two.

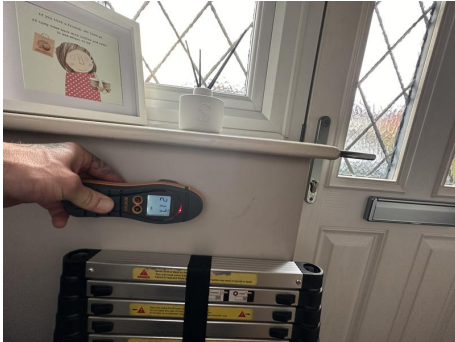
Photo 7 - Damp below front door window sill.

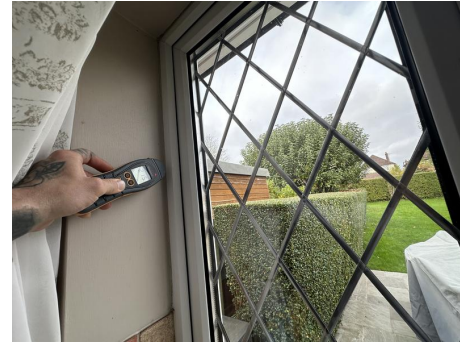
Photo 8 - Damp to side of kitchen window.

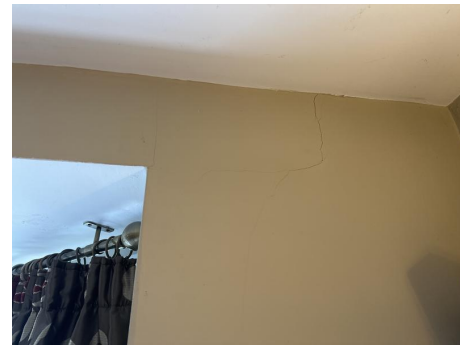
Photo 10 - Cracking above bay window.

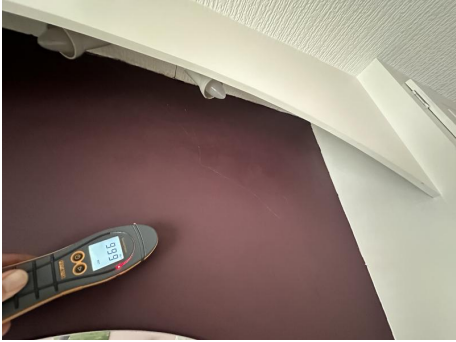
High levels of dampness were recorded within the plaster-work to the chimney breast within bedroom one. This indicates dampness is entering either through the flaunching, or the rear lead flashing (gutter back). Whilst the repairs to the flaunching are undertaken, it is advised the flashings are inspected for any signs of where water ingress may occur.

Photo 11 - Damp to bedroom one chimney breast.
