Address Example House

Prepared for Example Clients

Survey Date 24th October 2023

Prepared by James Brook BA(Hons), MSc, FRICS

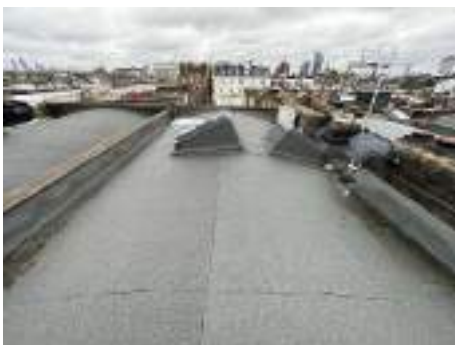
Photo 2

There are a few areas of weathered and untidy felt, with some small air pockets present, which could allow moisture to be trapped beneath overtime.

Bituminous felt roofs have much shorter life spans than traditional roofing materials, such as clay tiles or lead work, typically lasting between 10-20 years. Felt roofs can fail quickly especially if areas of damage are left unrepaired. Such roofs are deteriorated by UV light and as such normally have a layer of gravel protection, this should be maintained to prolong the life of the roof. The roof should be monitored and repaired as required. In the longer term it will be necessary to replace the roof covering.

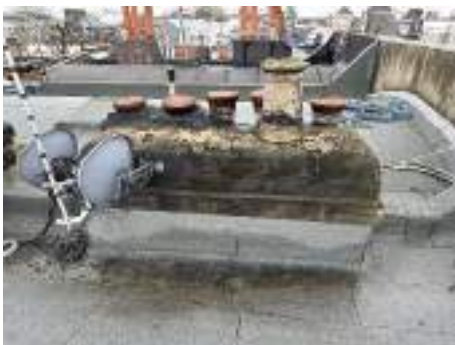
Photo 17

Overall, the chimney stacks are rather weathered and will require some works of repair and maintenance in the medium term.

The hidden parts of the chimneys should be inspected when repairs or annual maintenance is carried out. Any wants of repair noted should be carried out. As a matter of course you should monitor the internal parts of the chimney breasts for any defects or signs or dampness.

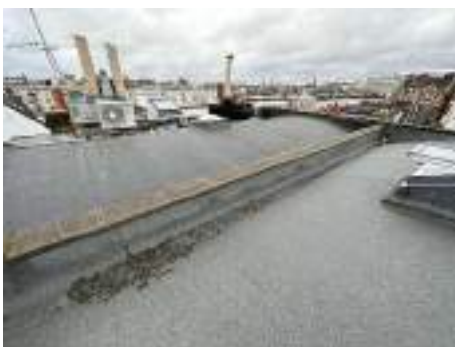
Photo 25

The roof above the utility room does not have any coping stones to project water away from the walls and prevent it soaking the brickwork below. This may be contributing to the issues of dampness and conditions to the utility room below. We would recommend that either copings or a lead capping is installed here in the short term. The other lower roof parapets do not have copings which sufficient project and these should be monitored for issues, again you may wish to replace the copings or install a lead capping.

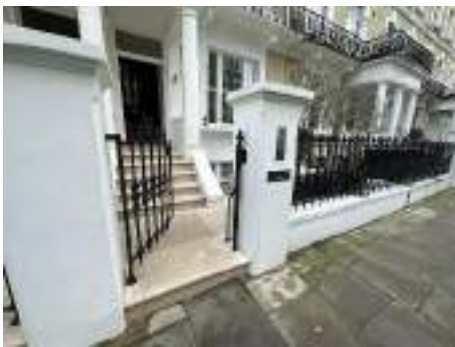
Photo 79

The front and rear gardens around the base of the main walls has been covered in a concrete hardstanding. This will restrict the natural surface water drainage and may allow rainwater to pond around the base of the walls which could result in penetrating dampness. Best practice would be to ensure that the hard standing has an adequate drainage fall so that the rainwater runs away from the walls. You should monitor the area during rainfall. If any signs of water ponding are noted then remedial works should be carried out to improve the drainage, such as a soakaway or channel drain.
