**Address** Example House

**Survey Date** 21st February 2022

**Prepared by** Jack Pye BSc Hons, MRICS  
Novello Chartered Surveyors

**Date of issue** 22nd February 2022

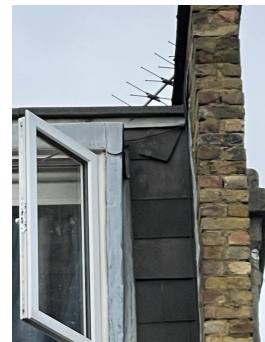
Photo 16 - Slipping slates to rear mansard

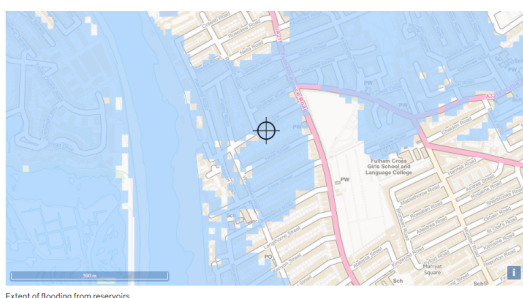
Photo 204

Extent of flooding from reservoirs
